**FINAL ROUND 10 DAM ASSESSMENT REPORT  
NIPSCO DH MITCHELL GENERATING STATION  
COAL ASH IMPOUNDMENTS**

**AUGUST 17, 2012**

Re: Round 10 Dam Assessment - Final Report  
EPA Contract No. EP10W001313  
NIPSCO – DII Mitchell Generating Station  
Coal Ash Impoundments  
Gary, Indiana

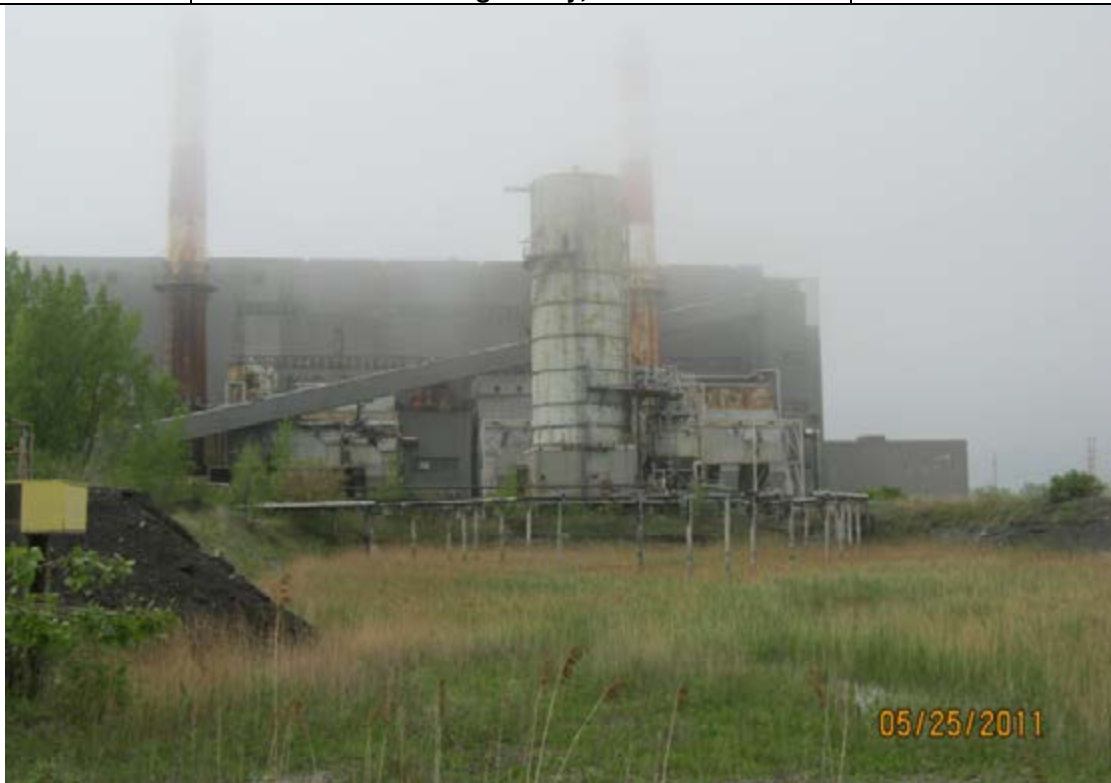
**Description:**  
Primary Settling Basin No. 1  
with the DHMGS in the  
background.

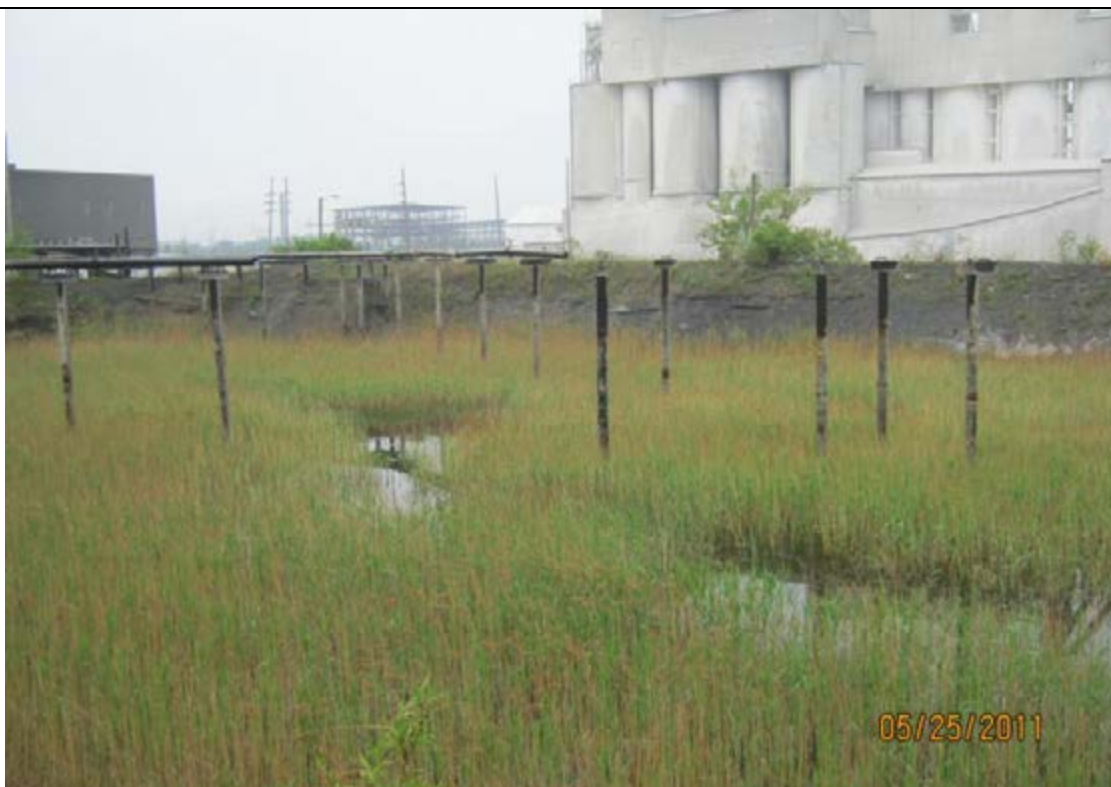
**Photo No.**  
**2**

**Description:**  
Primary Settling Basin  
No. 1.

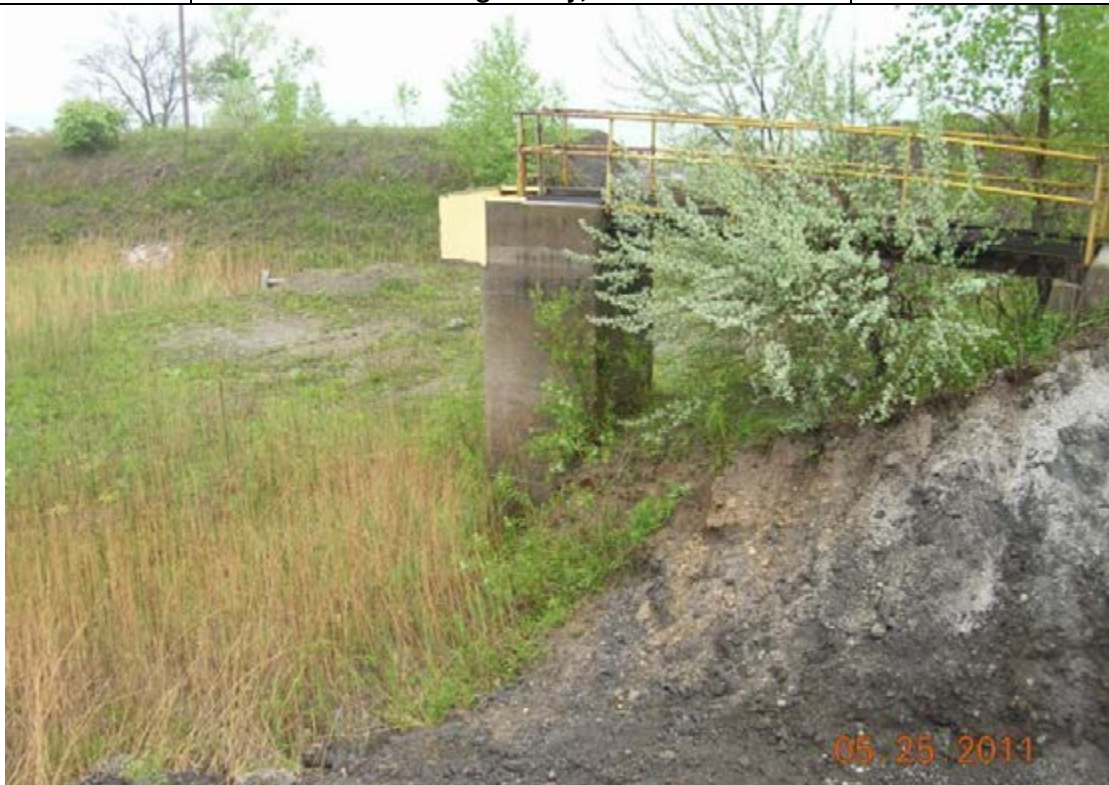
**Description:**  
Former discharge structure  
in Primary Settling Basin  
No. 1.

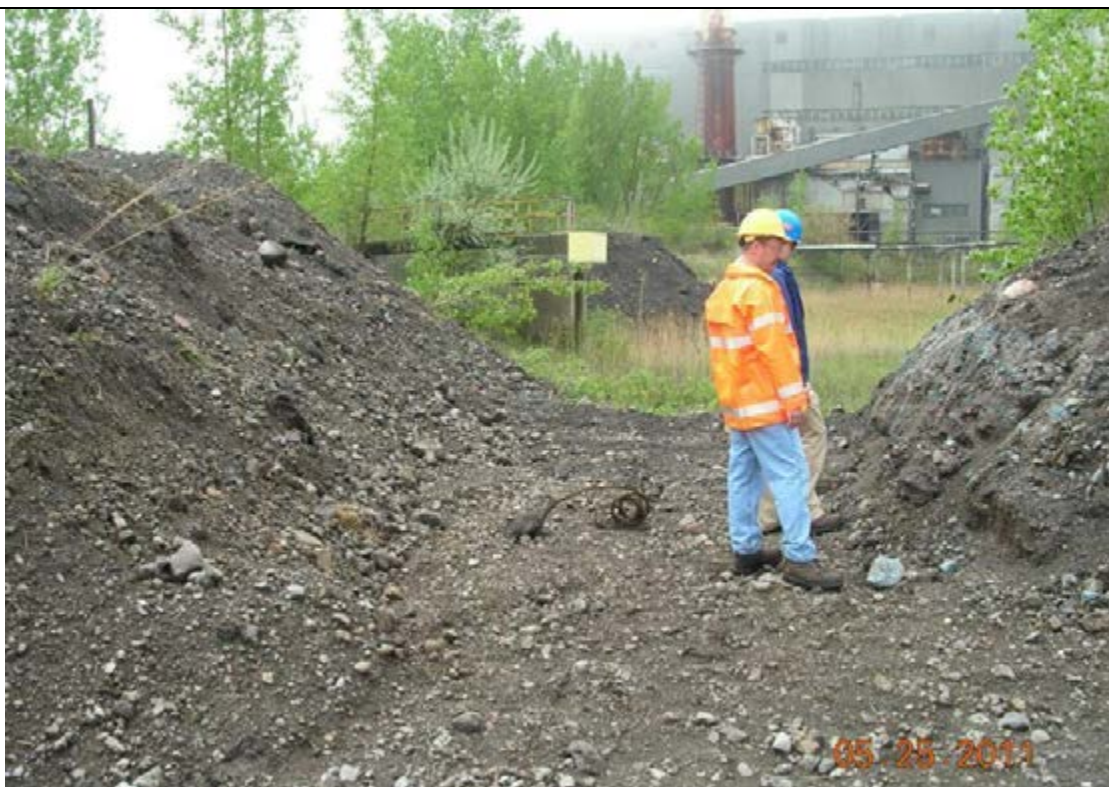
**Photo No.**  
**4**

The embankment was breached in at least four locations such that these four impoundments can no longer contain water. Since the impoundments are not lined, the majority of precipitation that enters the impoundments appears to infiltrate the ground.

**Description:**  
Breach in the Primary  
Settling Basin No. 1  
embankment.

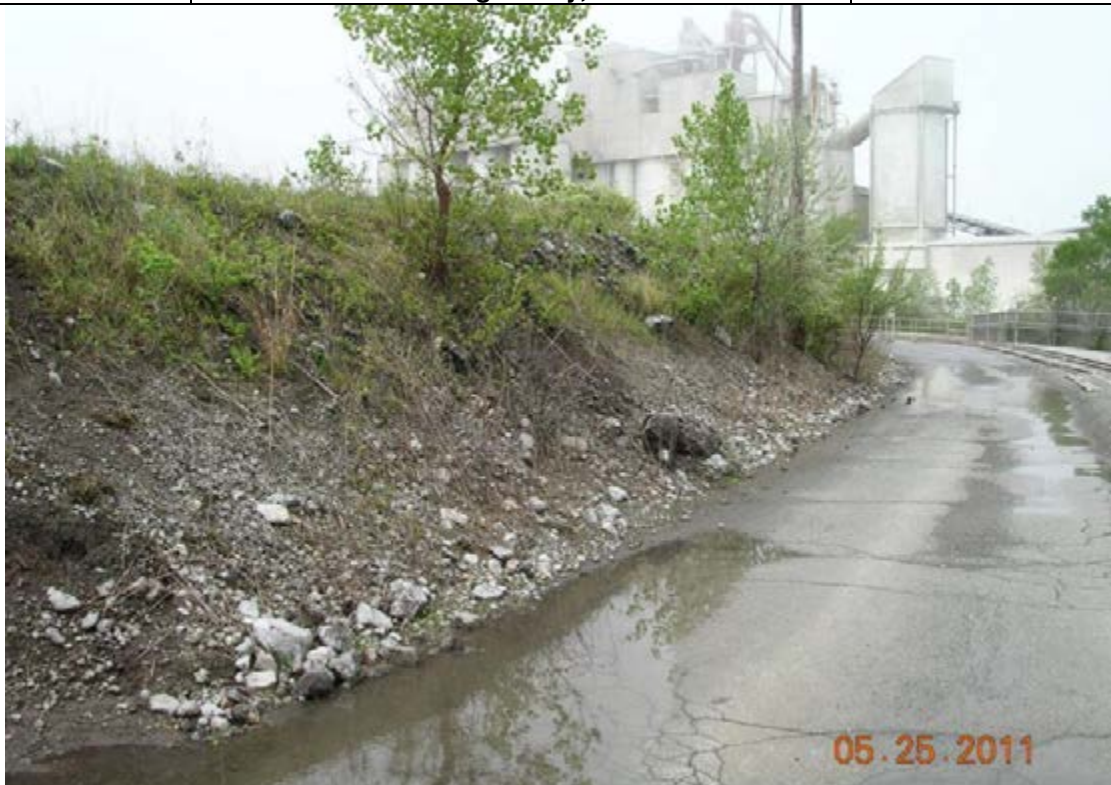
**Description:**  
Outer embankment of  
Primary Settling Basin No.  
1.

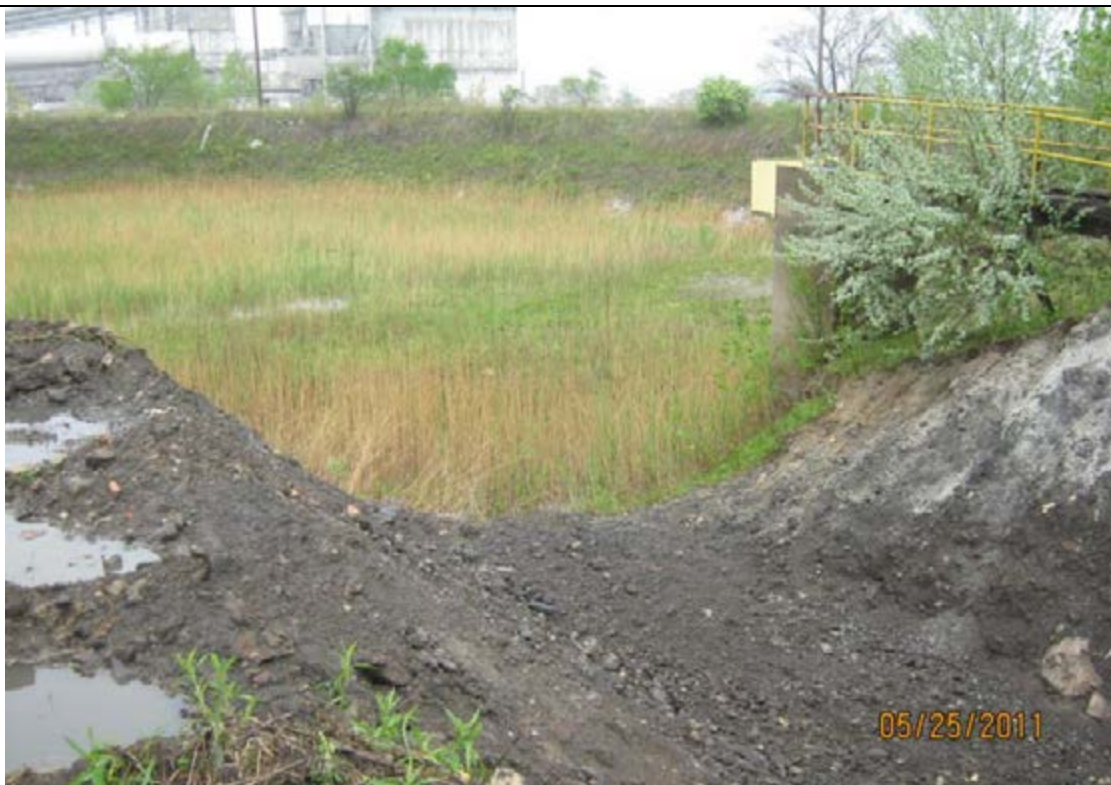
**Photo No.**  
**6**

**Description:**  
Breach between Primary  
Settling Basin No. 1 and  
Secondary Settling Basin  
No. 2.

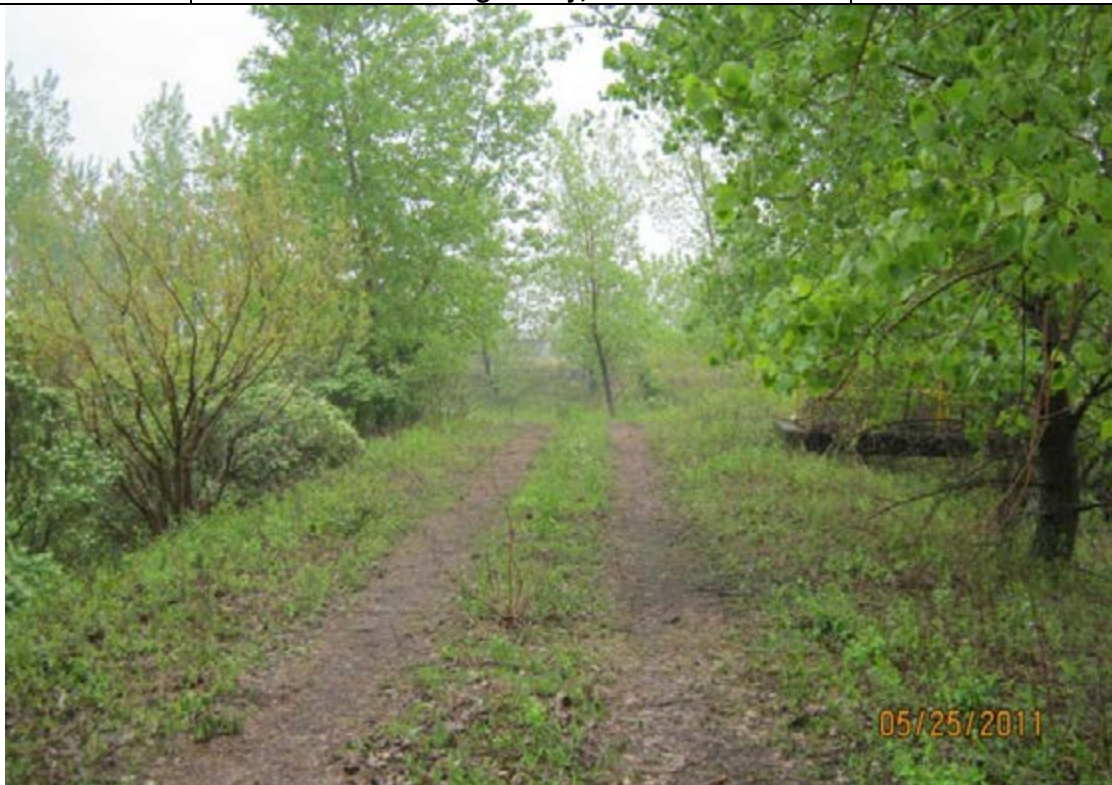
Embankment between the  
Primary Settling Basin No. 2  
(to the right of the  
photograph) and the  
Secondary Settling Basin  
No. 2 (to the left of the  
photograph).

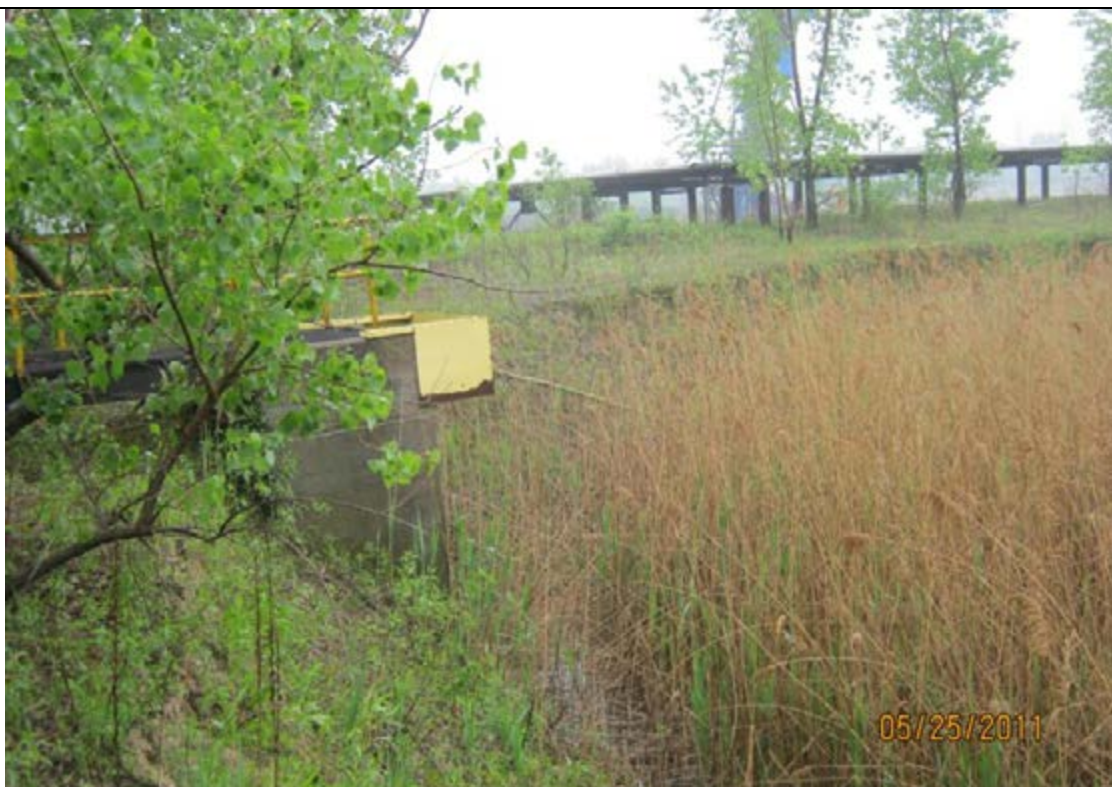
**Photo No.**  
**8**

Former discharge structure  
in the Primary Settling Basin  
No. 2.

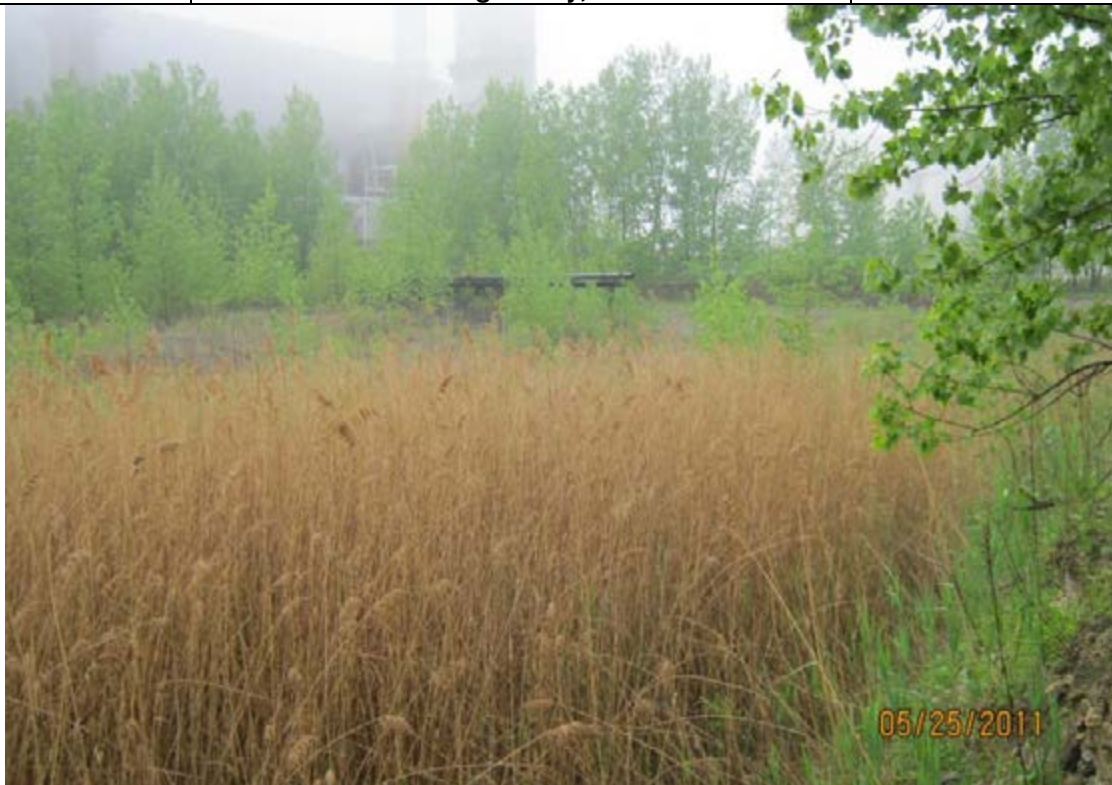
**Description:**  
Primary Settling Pond No. 2.

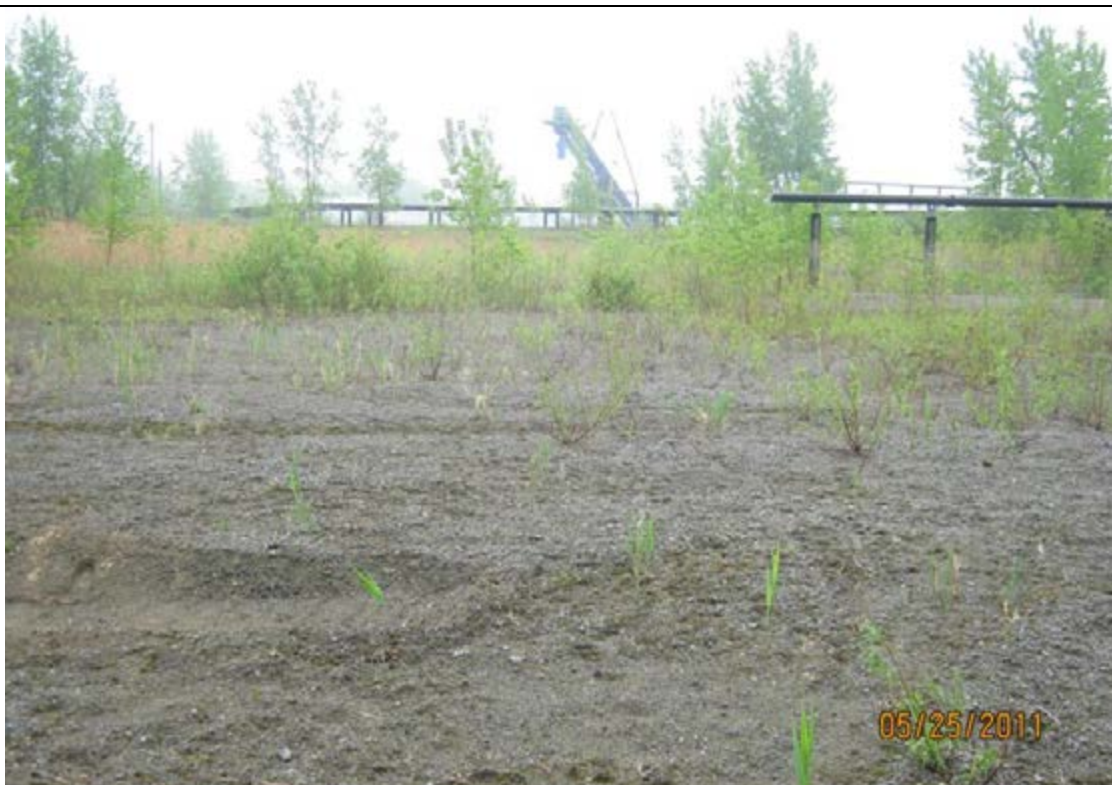
**Photo No.**  
**10**

**Description:**  
Ash remaining in Primary  
Settling Basin No. 2.

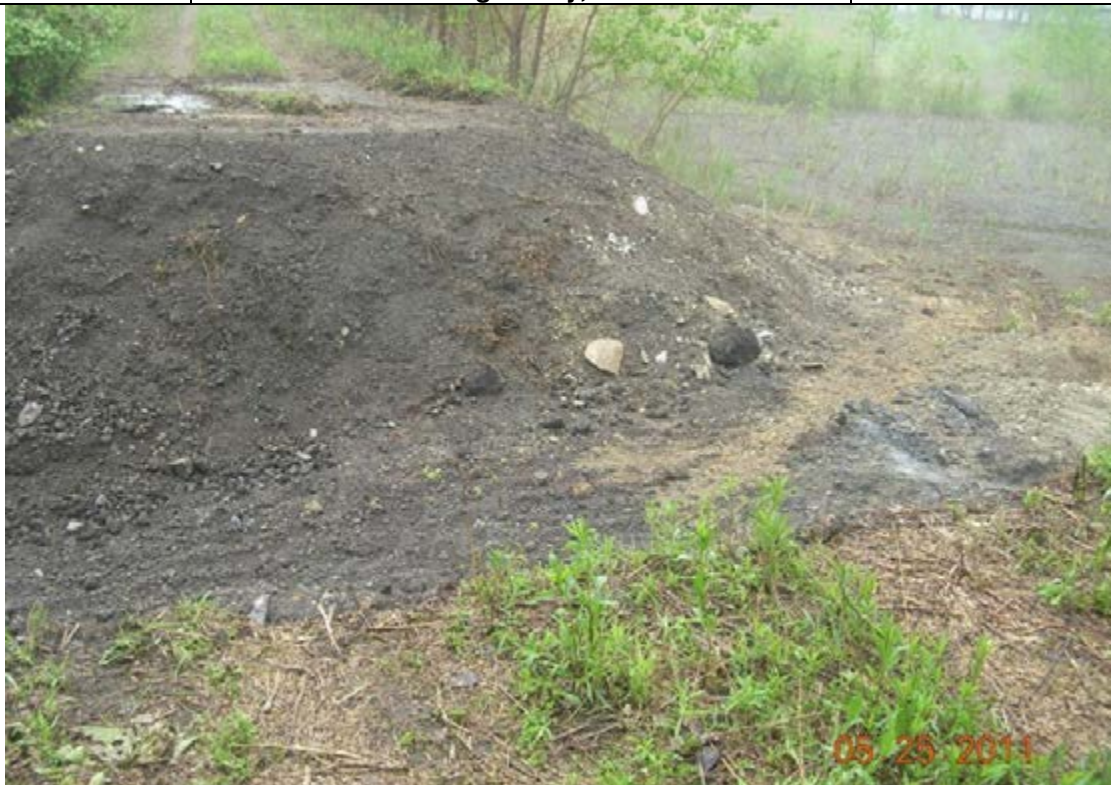
Breach between the Primary  
Settling Pond No. 2 and  
Secondary Settling Pond No.  
2.

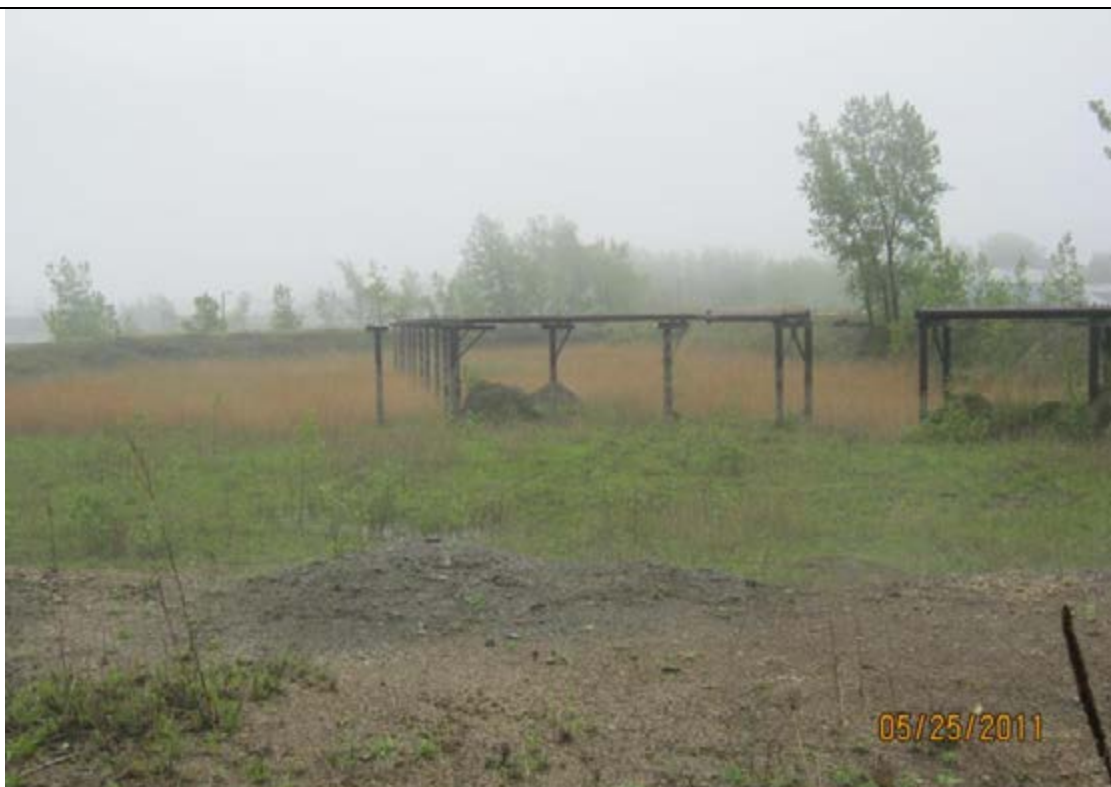
**Photo No.**  
**12**

Primary Settling Pond No. 3.

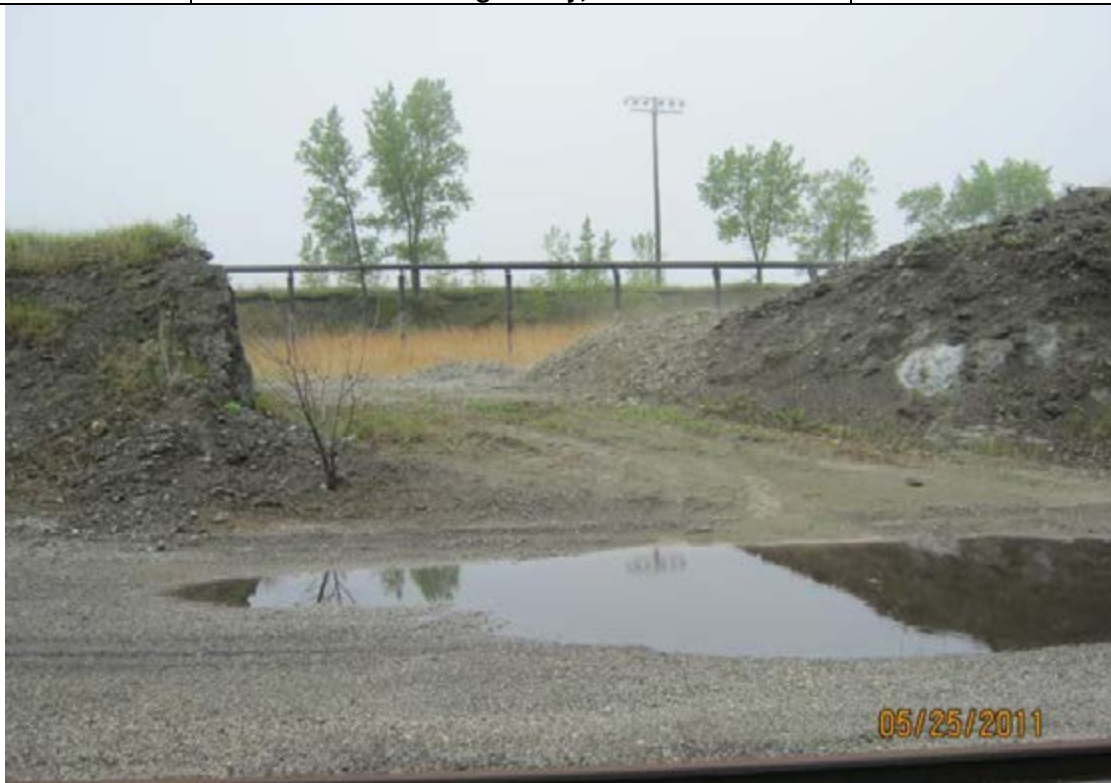
Primary No. 3 is separate from Primary No. 1, Primary No. 2, Secondary No. 1, and Secondary No. 2. With the exception of the location where the embankment was breached (refer to Figure 3 for the breach locations), the embankment appeared to be stable. Large trees up to 15-inch diameter were growing on the embankments. Thick vegetation was growing on the embankments and within the impoundments. The majority of the interior and exterior slope could not be observed due to the vegetation growth. The embankment was breached in at least one location such that Primary No. 3 can no longer contain water. Since this impoundment is not lined, the majority of precipitation that enters Primary No. 3 appears to infiltrate the ground.

**Description:**  
Breach in Primary Settling  
Pond No. 3.

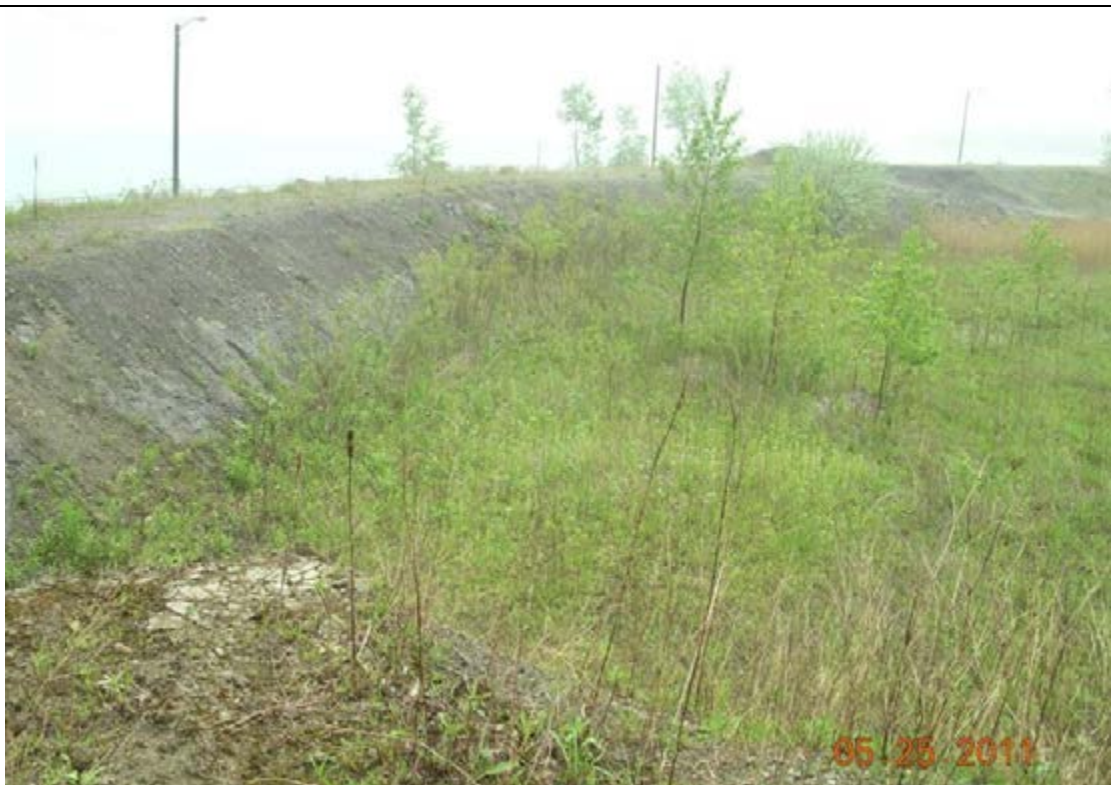
**Photo No.**  
**14**

**Description:**  
Northern embankment in  
Primary Settling Pond No. 3.

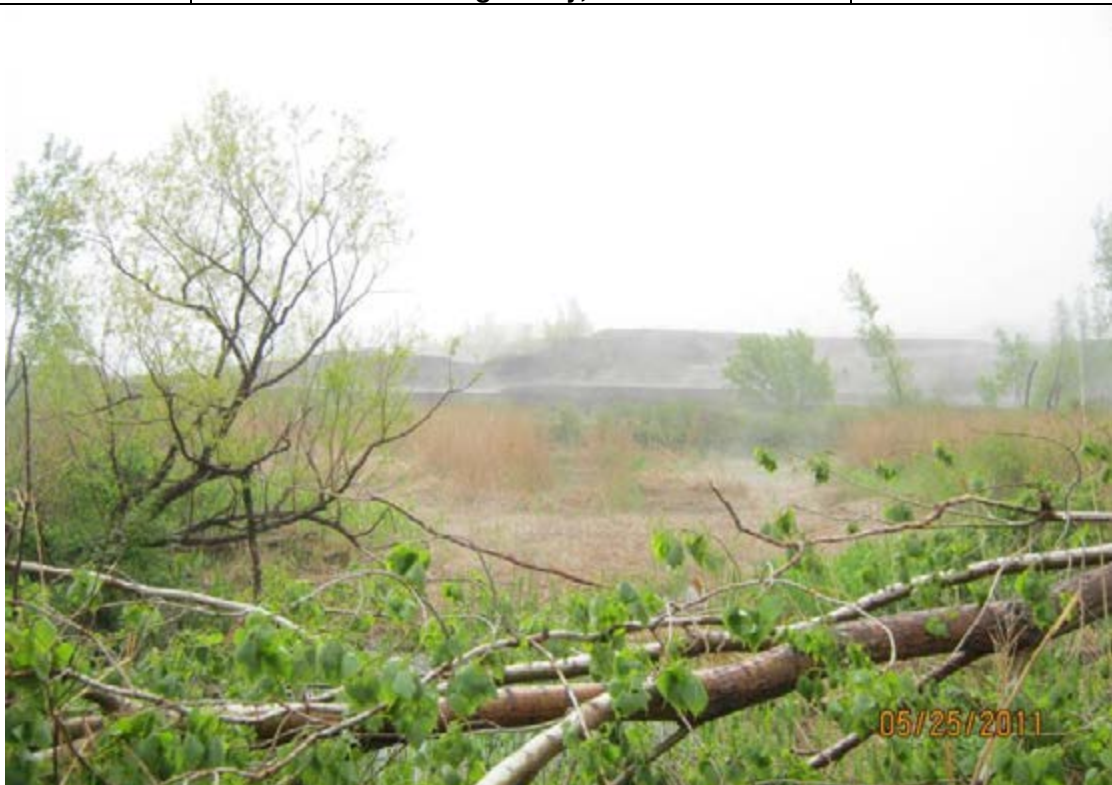
Primary No. 4 is separate from Primary No. 1, Primary No. 2, Secondary No. 1, Secondary No. 2, and from Primary No. 3. Primary No. 4 is incised. Large trees up to 15-inch diameter were growing on the embankments. Thick vegetation was growing on the embankments and within this impoundment. The majority of the interior and exterior slope could not be observed due to the vegetation growth. Some water was noted in Primary No. 4. Since this impoundment is not lined, the majority of precipitation that enters Primary No. 4 appears to infiltrate the ground.

**Description:**  
Overview of Primary  
Settling Pond No. 4.

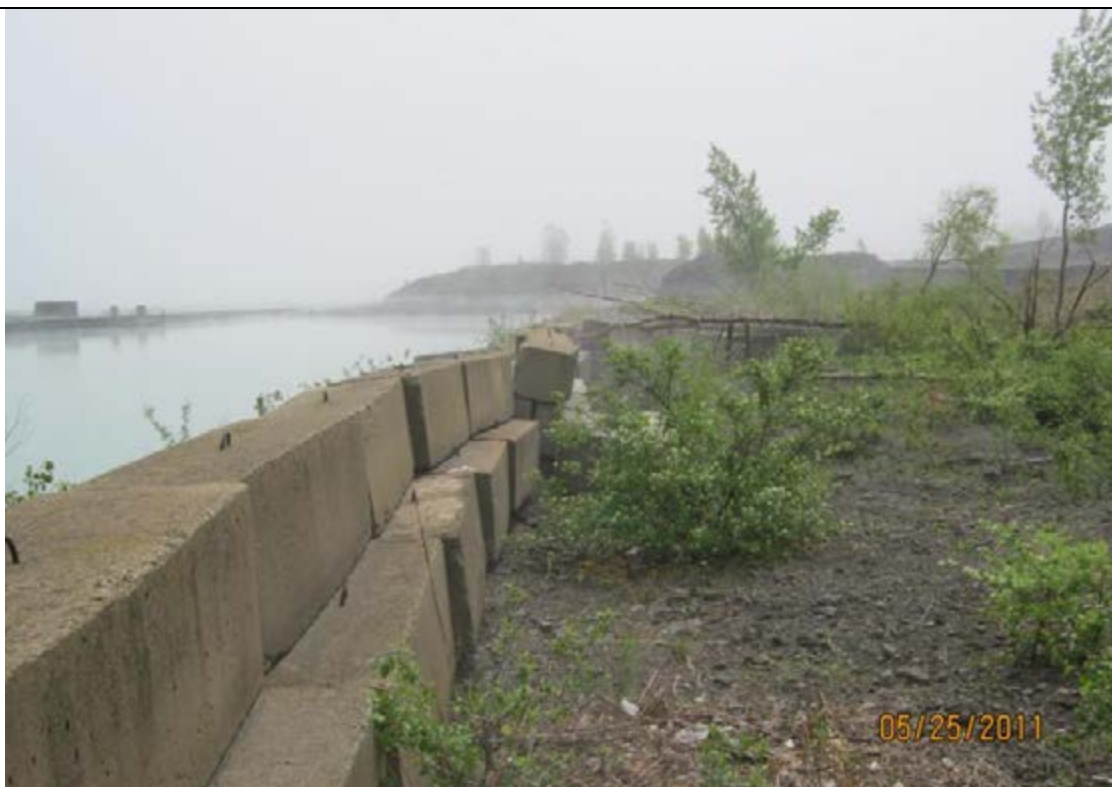
**Photo No.**  
**16**

**Description:**  
Embankment retaining wall  
between Primary Settling  
Pond No. 4 and the US Steel  
settling pond.

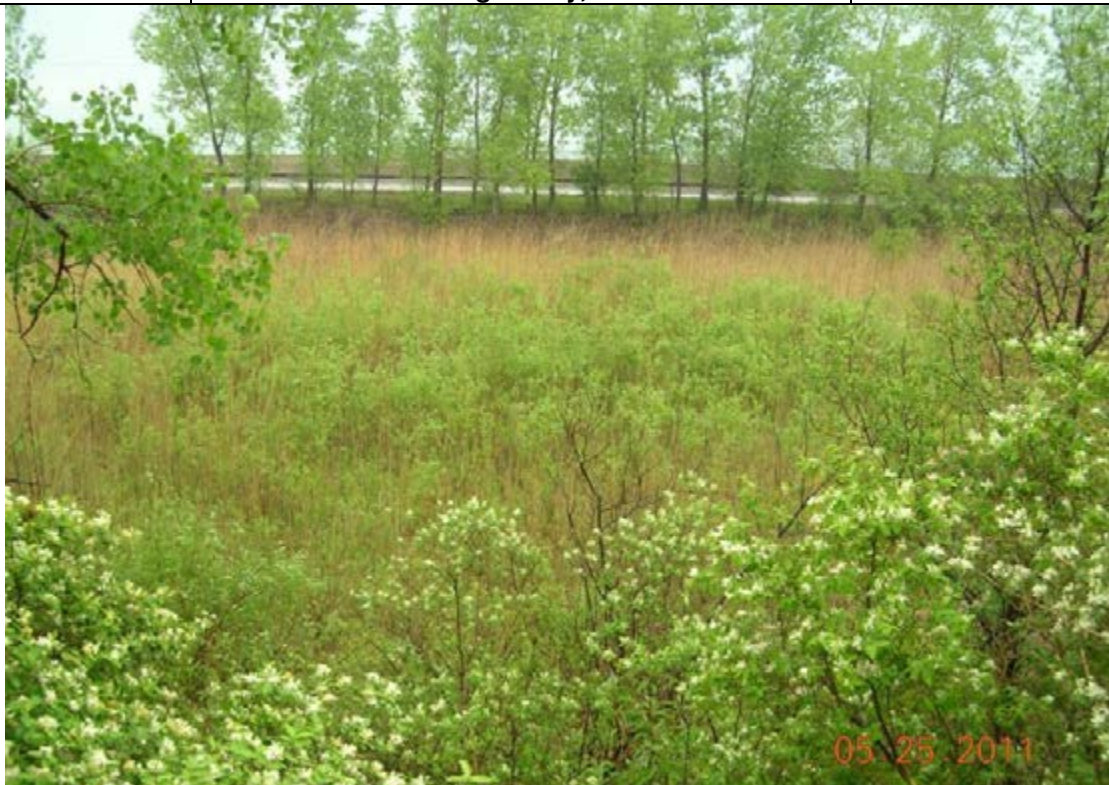
**Description:**  
Overview of Secondary  
Settling Basin No. 1.

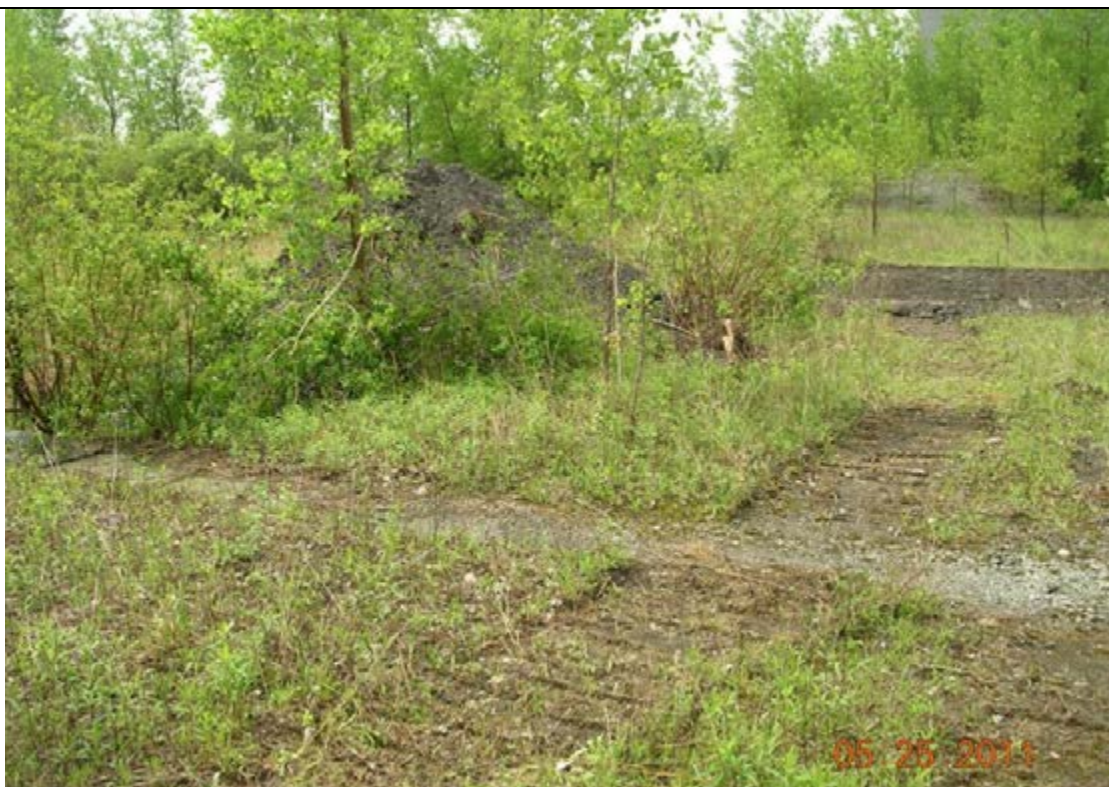
**Photo No.**  
**18**

**Description:**  
Secondary Settling Pond No.  
1. The breach between  
Secondary Settling Pond No.  
2 and Secondary Settling  
Pond No. 1 is shown on the  
right side of the photograph.

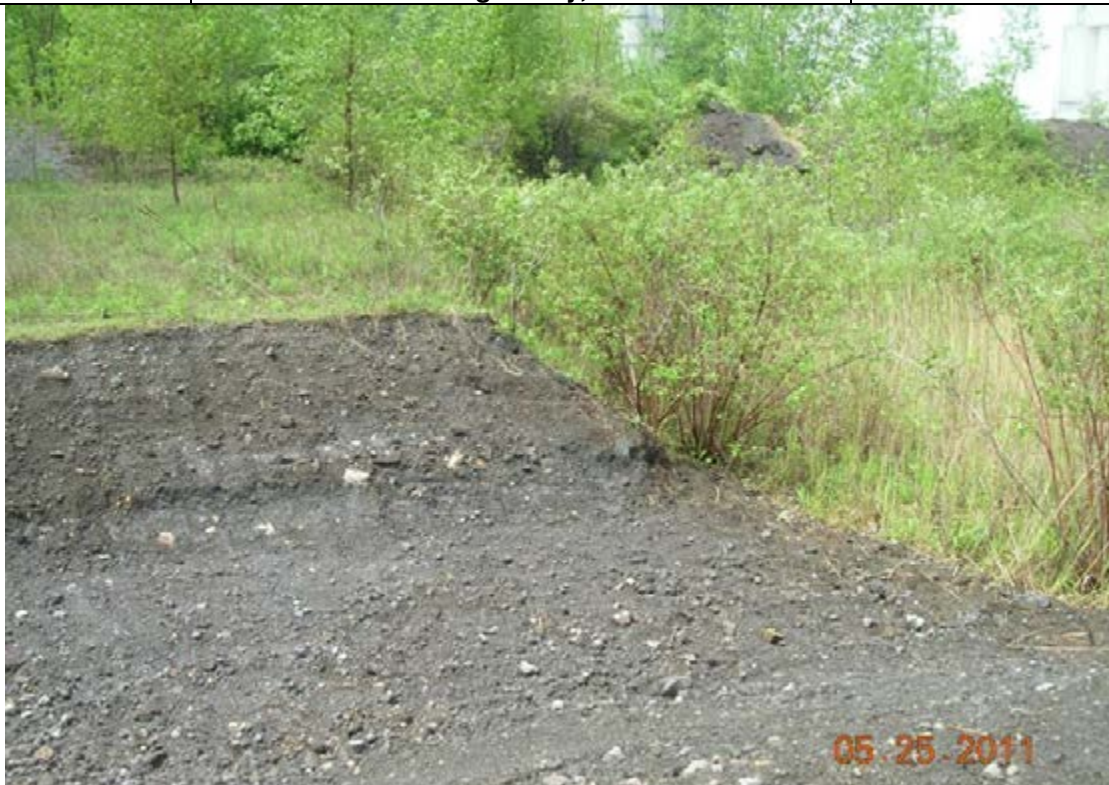
The breach between  
Secondary Settling Pond No.  
2 and Secondary Settling  
Pond No. 1.

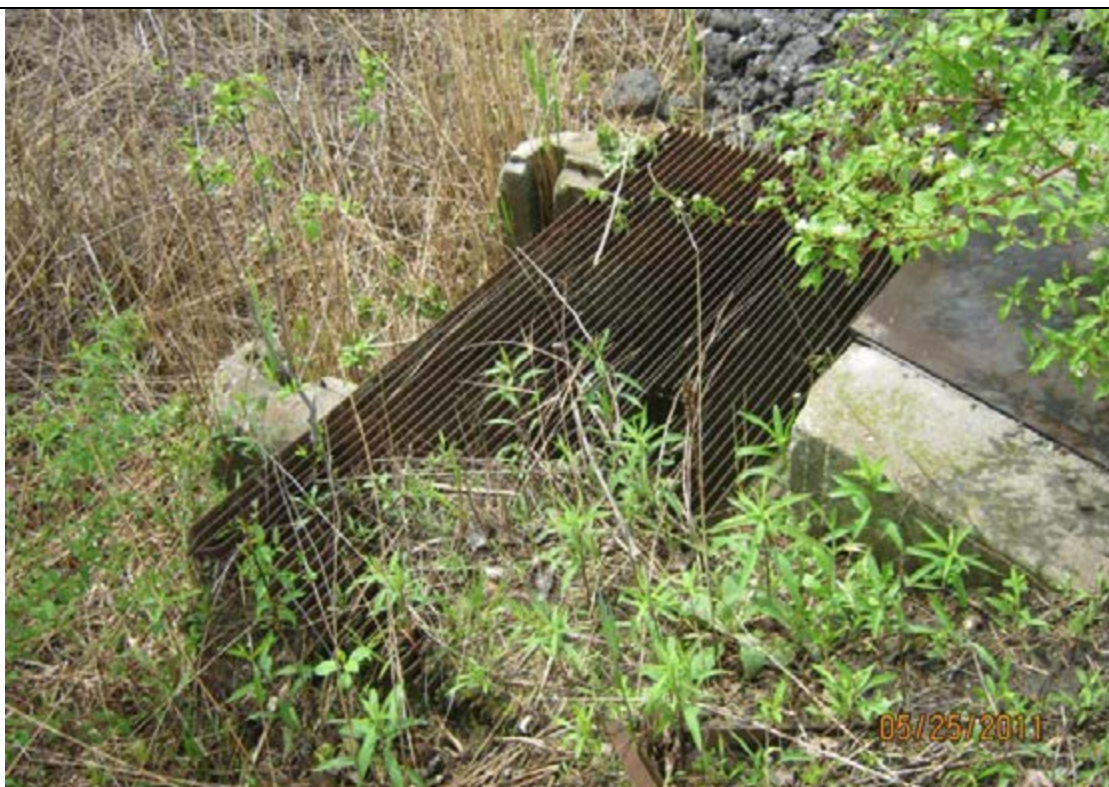
**Photo No.**  
**20**

Former discharge structure  
in Secondary Settling Pond  
No. 1.

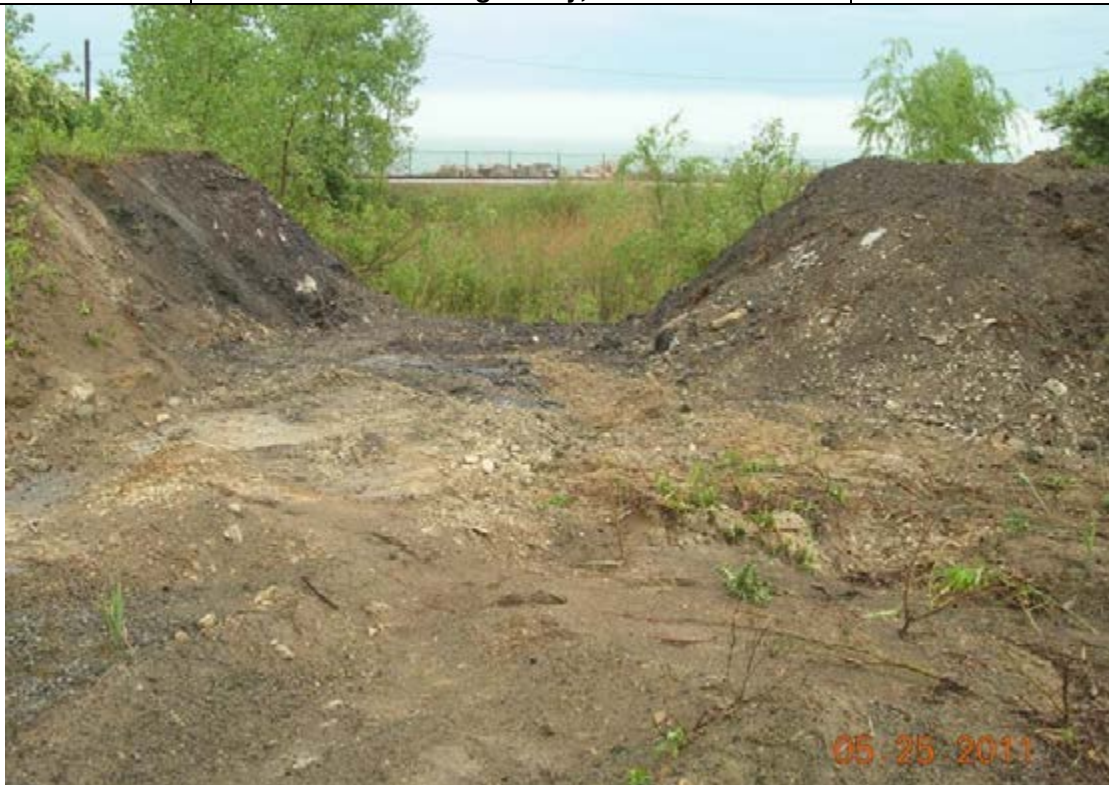
Breach between the Primary  
Settling Pond No. 2 and  
Secondary Settling Pond No.  
2.

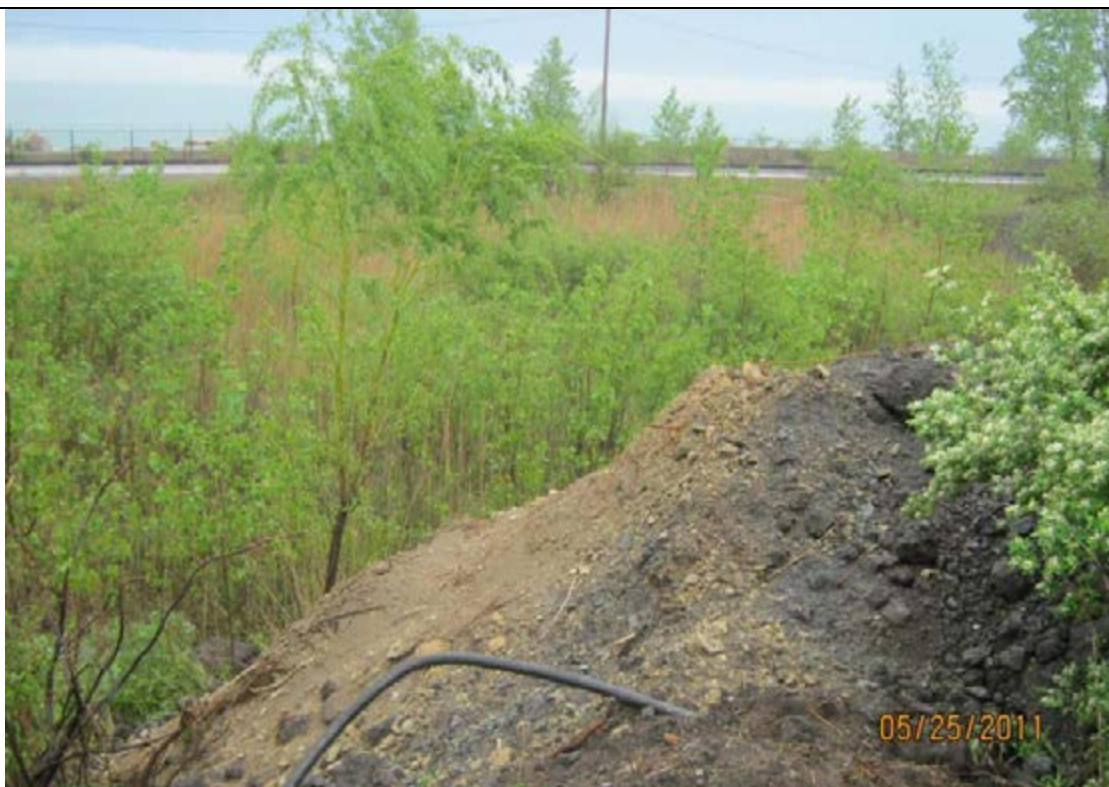
**Photo No.**  
**22**

Overview of Secondary  
Settling Pond No. 2.

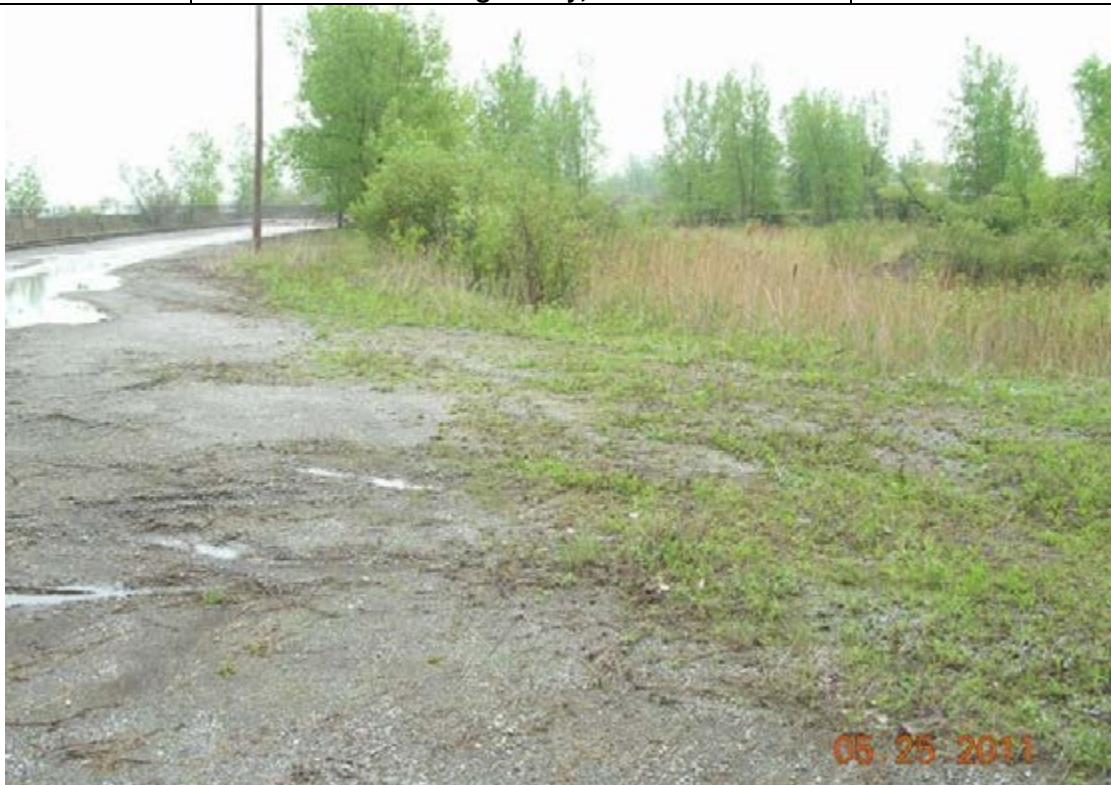
**Description:**  
Overview of Secondary  
Settling Pond No. 2.

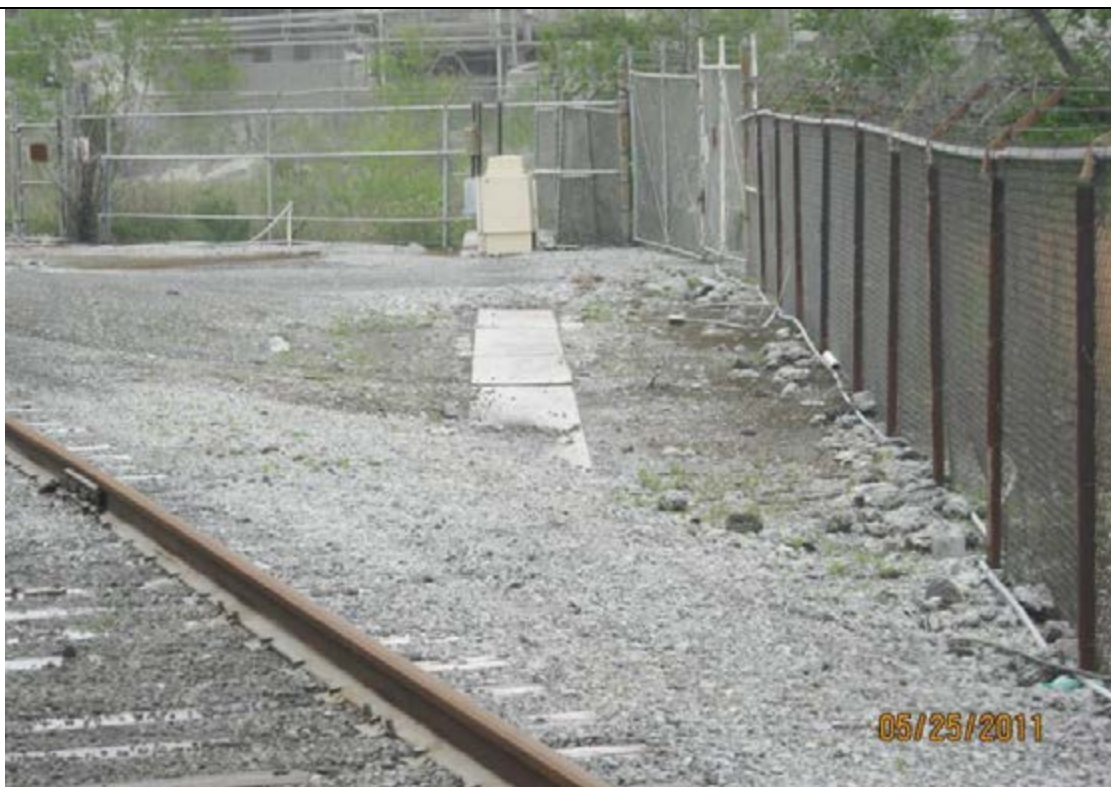
**Photo No.**  
**24**

**Description:**  
Former location of NPDES  
discharge.
